Tractor Drawbar Clevis on PTO Driven Implements

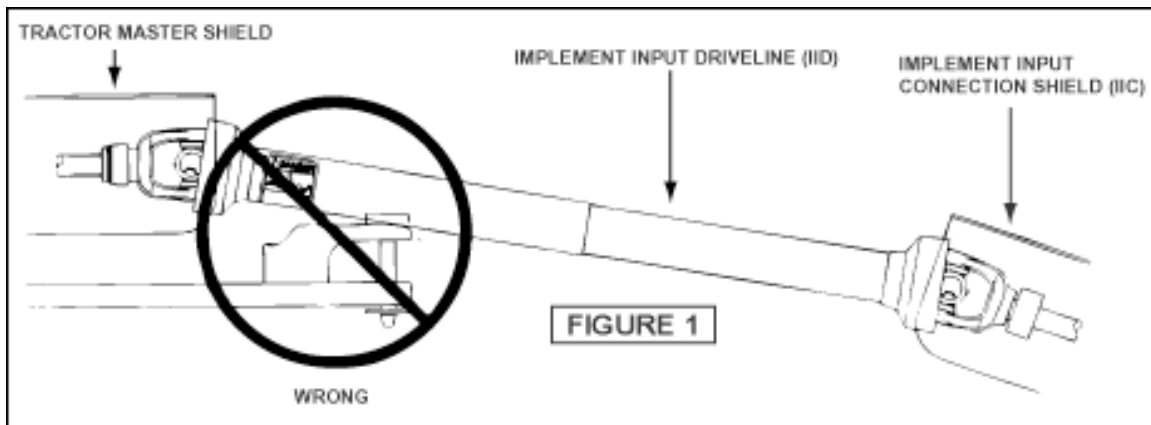
If this implement is attached to a tractor with a clevis hitch (hammer-strap) style drawbar, the hammer-strap must be removed to prevent damage to the IID guarding and the IID telescoping members. [See Figure 1]

Clevis Hitches—A tractor drawbar equipped with a clevis hitch (hammer-strap) can cause interference with the PTO driveline IID [Implement Input Driveline]. This interference can cause serious damage to the IID guarding and the IID telescoping members. The clevis hitch on the tractor must be removed.

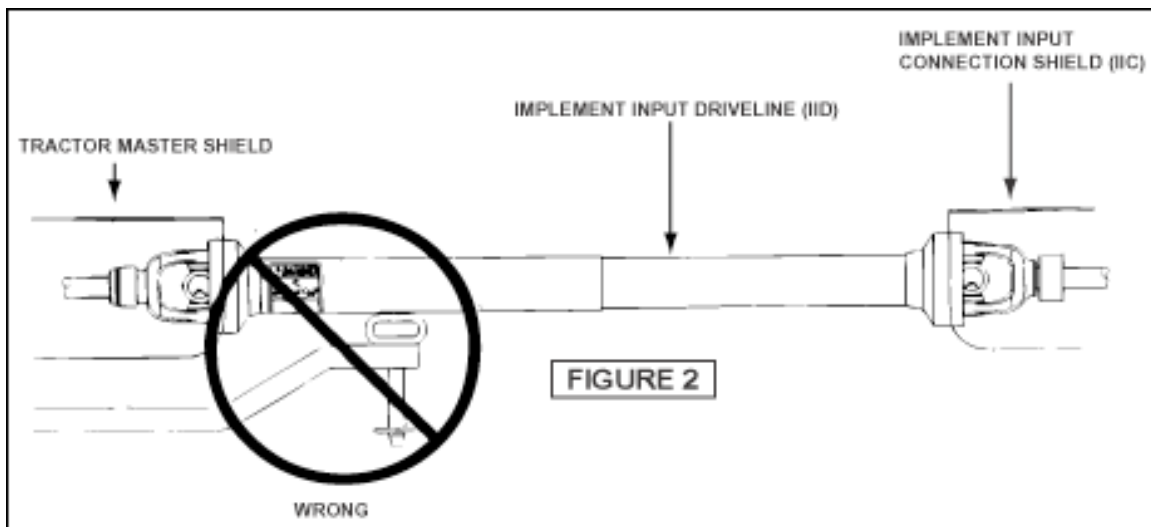
If this implement is attached to the tractor with an offset in the drawbar, be certain it is in the down position to prevent damage to the IID guarding and the IID telescoping member. [See Figure 2.]
